Chapter 2

THE ACCOUNT OF WORLD TRADE CENTER 1

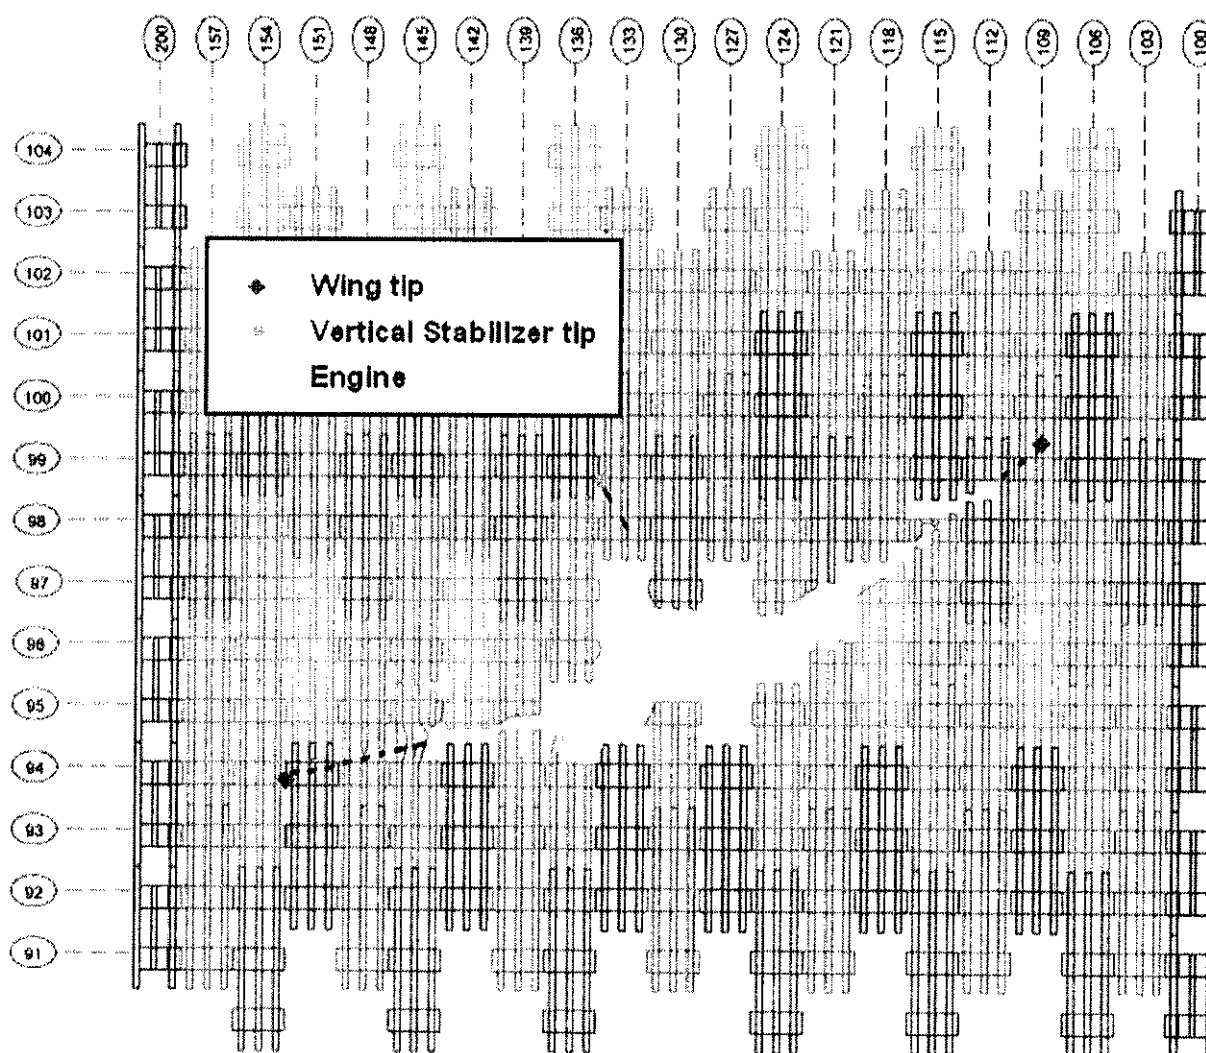
The aircraft did the most damage to the 95th and 96th floors. The fuel-heavy inner left wing hit the 95th floor slab, breaking it over the full 60 ft depth of tenant space and another 20 ft into the building core. The fuselage was centered on the 96th floor slab and filled the 95th and 96th floors top to bottom. The severity of the impact was clear. A wheel from the left wing landing gear flew through multiple partitions, through the core of the building, and became embedded in one of the exterior column panels on the south side of the tower. The impact severed the bolts connecting the panel to its neighbors, and the panel and tire landed on Cedar Street, some 700 ft to the south. A second wheel landed 700 ft further south. Within the two floors, 15 to 18 perimeter columns and five to six core columns were severed, and an additional one to three core columns were heavily damaged. A 40 ft width of the 96th floor slab was broken 80 ft into the building. The insulation was knocked off nearly all the core columns and over a 40 ft width of floor trusses from the south end of the core to the south face of the tower.

Figure 2-3. South face damage of WTC 1 with key aircraft component locations marked.

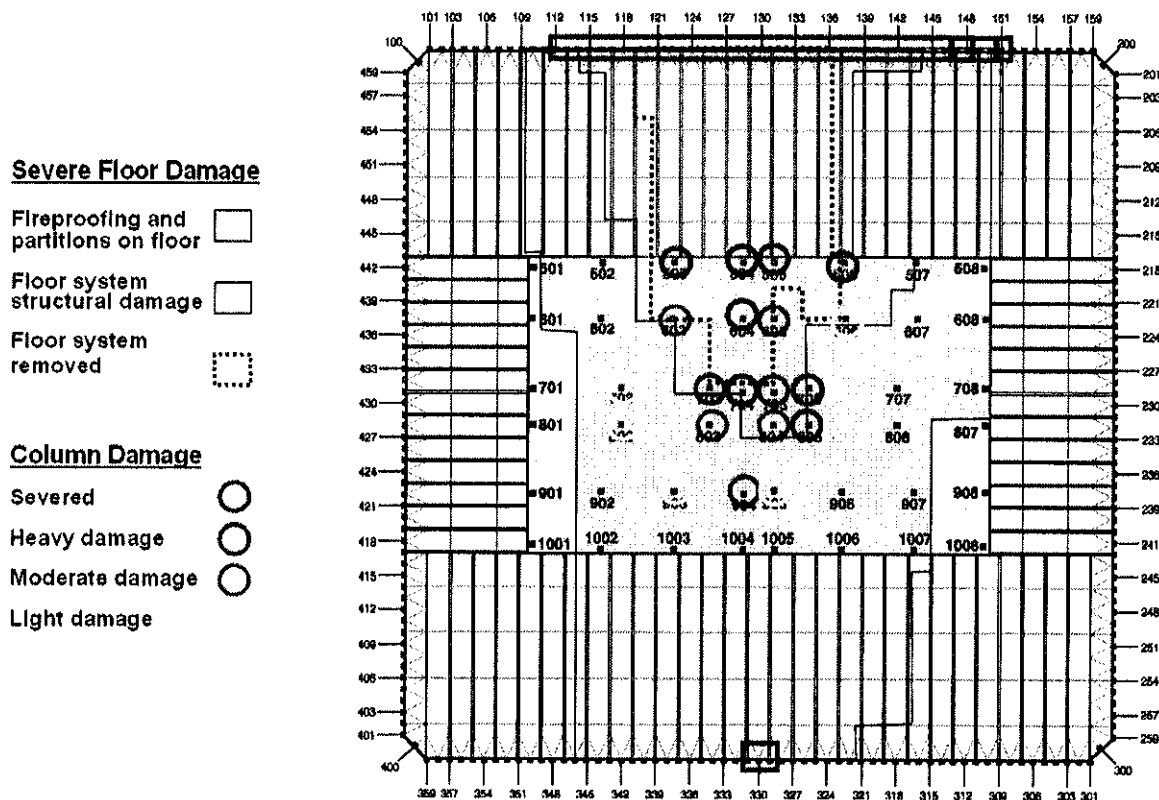
This devastation took 0.7 s. The structural and insulation damage was considerable (Figure 2-4) and was estimated to be:

- 35 exterior columns severed, 2 heavily damaged.
- 6 core columns severed, 3 heavily damaged.

- 43 of 47 core columns stripped of insulation on one or more floors.
- Insulation stripped from trusses covering 60,000 ft² of floor area.

Figure 2-4. Simulation of cumulative aircraft impact damage to floors 93 through 98 in WTC 1.

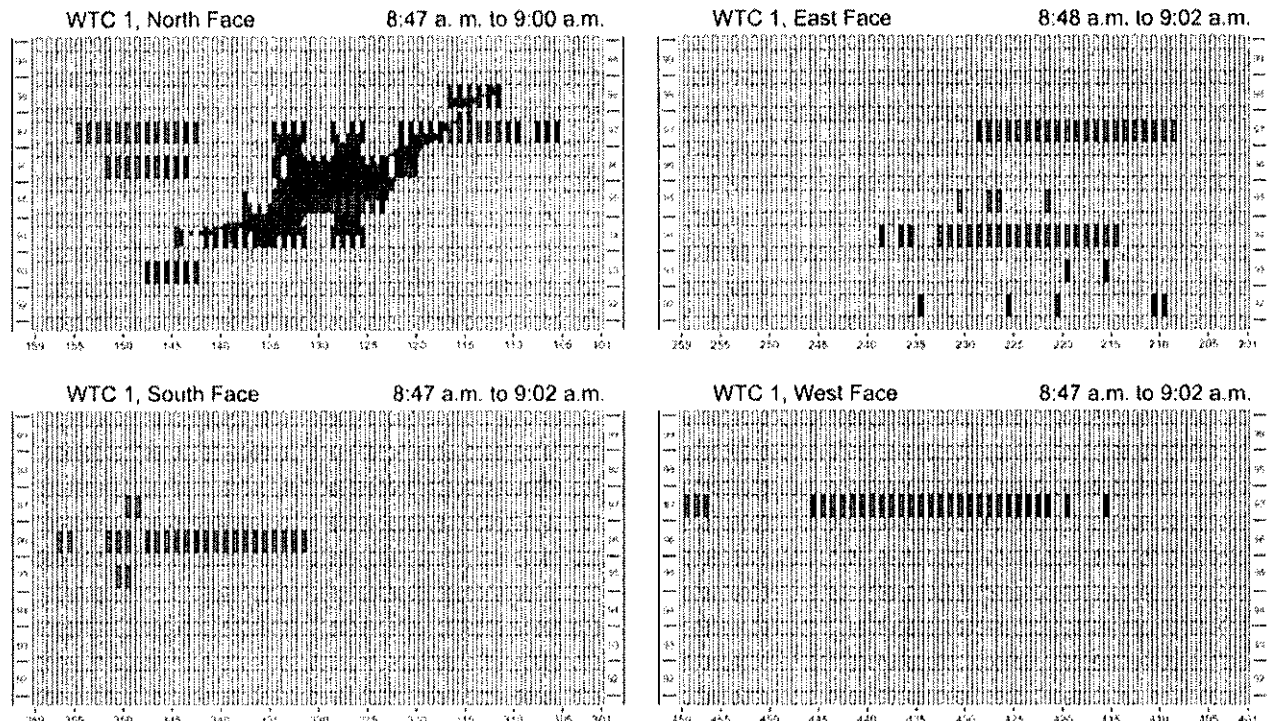
Figure 2-5. Representation of exterior views of the fires on the four faces of WTC 1 from 8:47 a.m. to about 9:02 a.m.

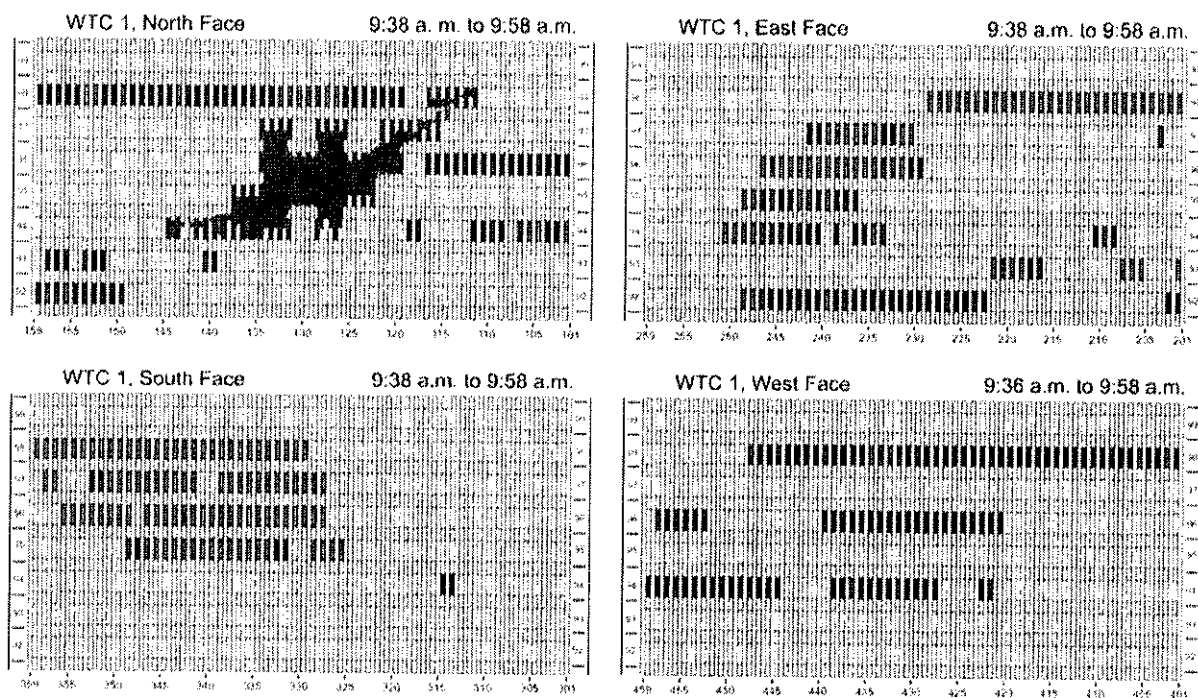
Seventy-five minutes after the impact, approaching 10:00 a.m., the fire on the 97th floor had begun to burn itself out, but the fire on the 94th floor had intensified and filled much of the north half of the floor (Figure 2–7). Starting about 9:30 a.m., there were vigorous fires on nearly the full perimeter of the 98th floor. There was still almost no burning on the 99th floor or above.

Figure 2–7. Representation of exterior views of the fires on the four faces of WTC 1 from about 9:38 a.m. to 9:58 a.m.

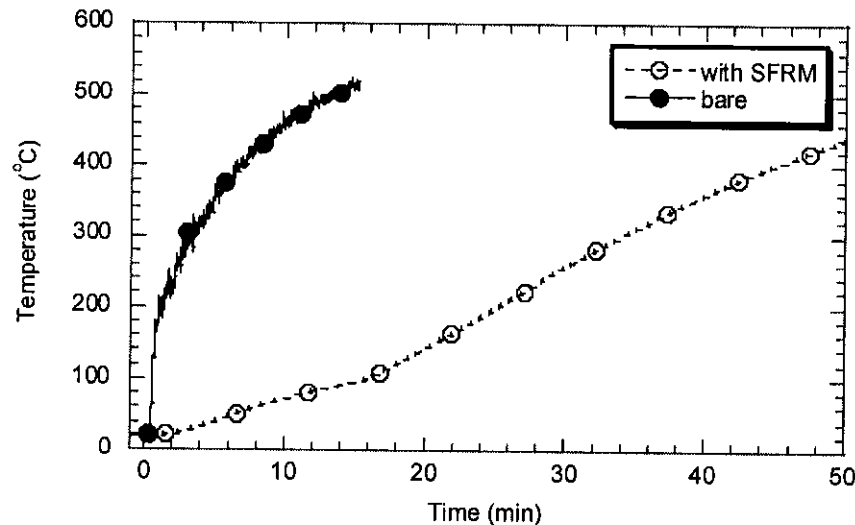
The perimeter columns, floors, and core columns were immersed in these hot gases and began to weaken. Where the insulation was dislodged, the temperature of the steel rose rapidly, in contrast to steel members where insulation was intact (Figure 2–8). The heaviest core columns with damaged insulation heated slowly, as the absorbed heat was dissipated through their massive cross sections. The temperatures of the lighter columns and the floor slabs rose more quickly, and those of the stripped trusses even more so.

Figure 2–8. Steel surface temperatures on the bottom chords of fire-exposed trusses, uninsulated and insulated with ¾ in. of BLAZE-SHIELD DC/F.

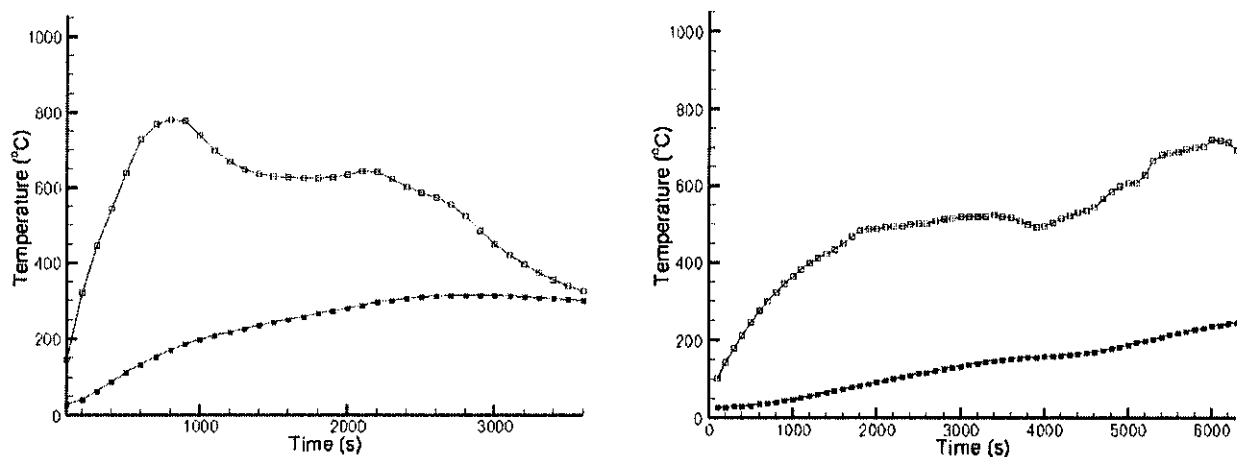
Figure 2-10. Simulated temperatures of two adjacent trusses (left) and two adjacent perimeter columns (right) exposed to the fires in WTC 1.

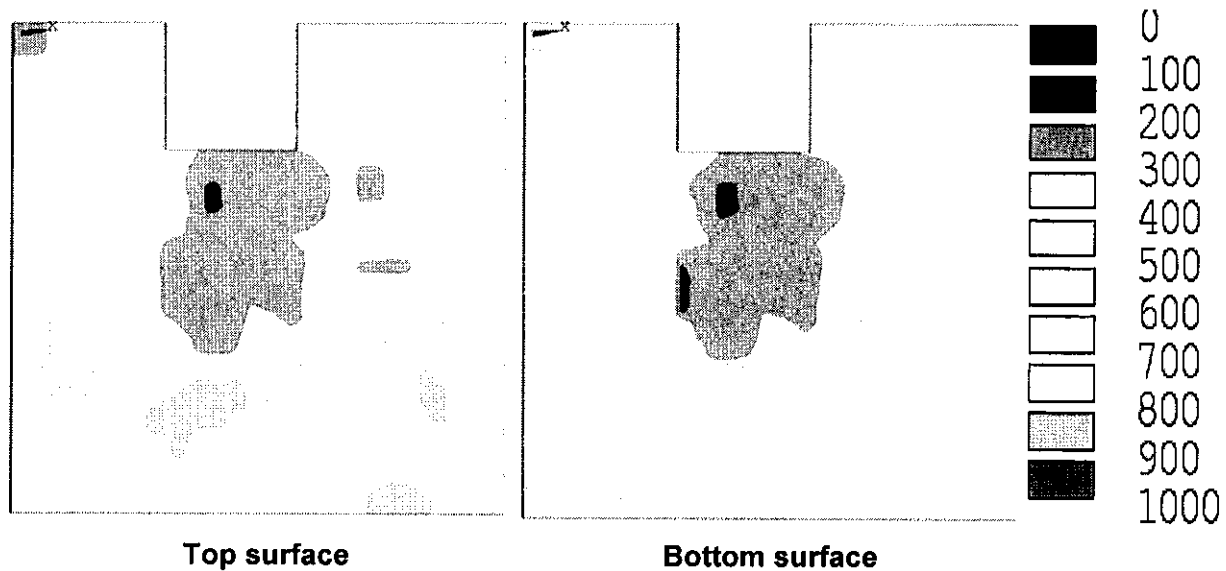
Simultaneously, the fires were creating another problem for the tower. The floors of the 93rd through the 97th stories were being heated both by the hot gases from below and by thermal radiation from the fires on the floor above (Figure 2-11). On the south side of the building, where the fires were heating the long-span trusses whose SFRM had been dislodged, the floors began to sag. In so doing, they began pulling inward on their connections to the south face and to the core columns. Pull-in forces due to the sagging floors did not fail the floor connections in most areas.

Figure 2-11. Temperature contours (°C) on the top and bottom faces of the concrete slab (96th floor, WTC 1) at 100 min after impact. A portion of the concrete slab on the north face (top) was damaged by the impact of the aircraft.

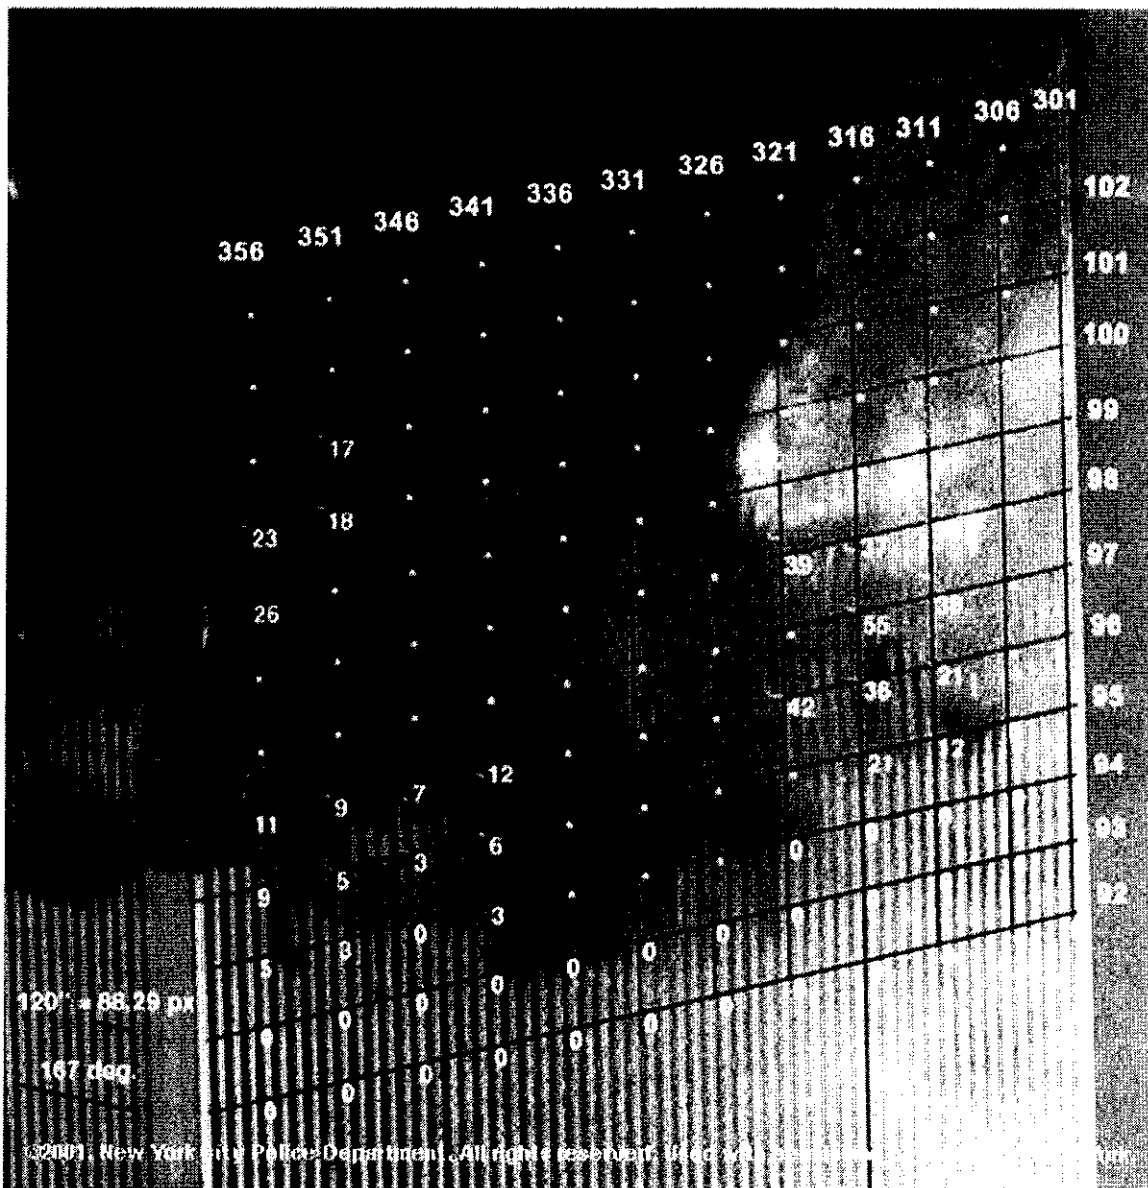
The sagging of the floors had increased. Although the floors on the north side of the tower had sagged first, they contracted due to cooling when the fires moved toward the south. Now, the south side floors had sagged to the point where the south perimeter columns bowed inward (Figure 2–12). By 10:23 a.m., the south exterior wall had bowed inward as much as 55 in.

Figure 2-12. South face of WTC 1 at 10:23 a.m., showing inward buckling (in inches) of perimeter columns.

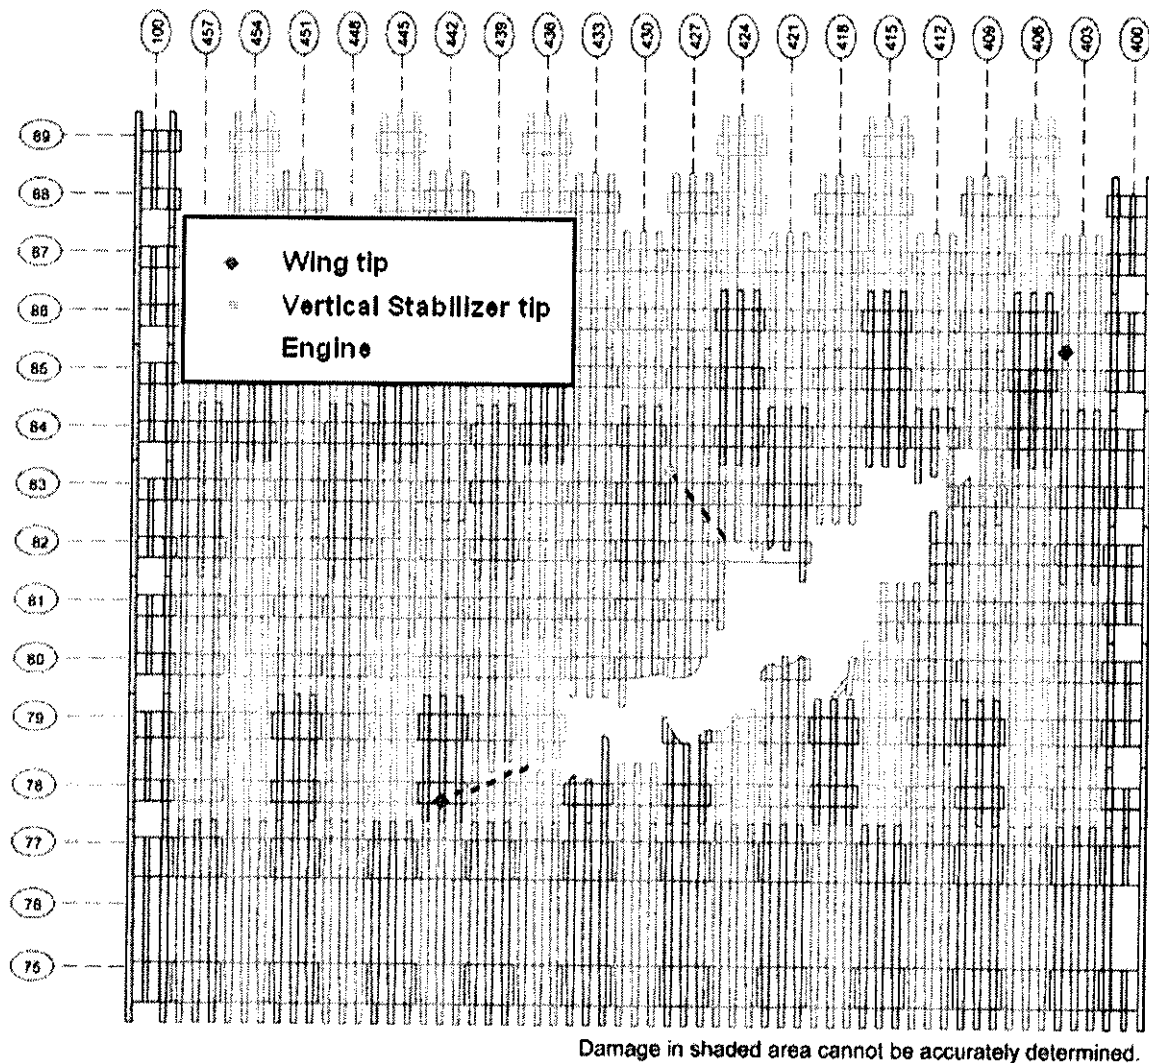
bank angle was steeper than that of AA Flight 11, this entry wound stretched over nine floors, from 77 to 85, rather than eight in WTC 1 (Figure 3–2). The occupancy of those floors is shown in Table 3–1.

Figure 3–2. South face damage of WTC 2 with key aircraft component locations marked.

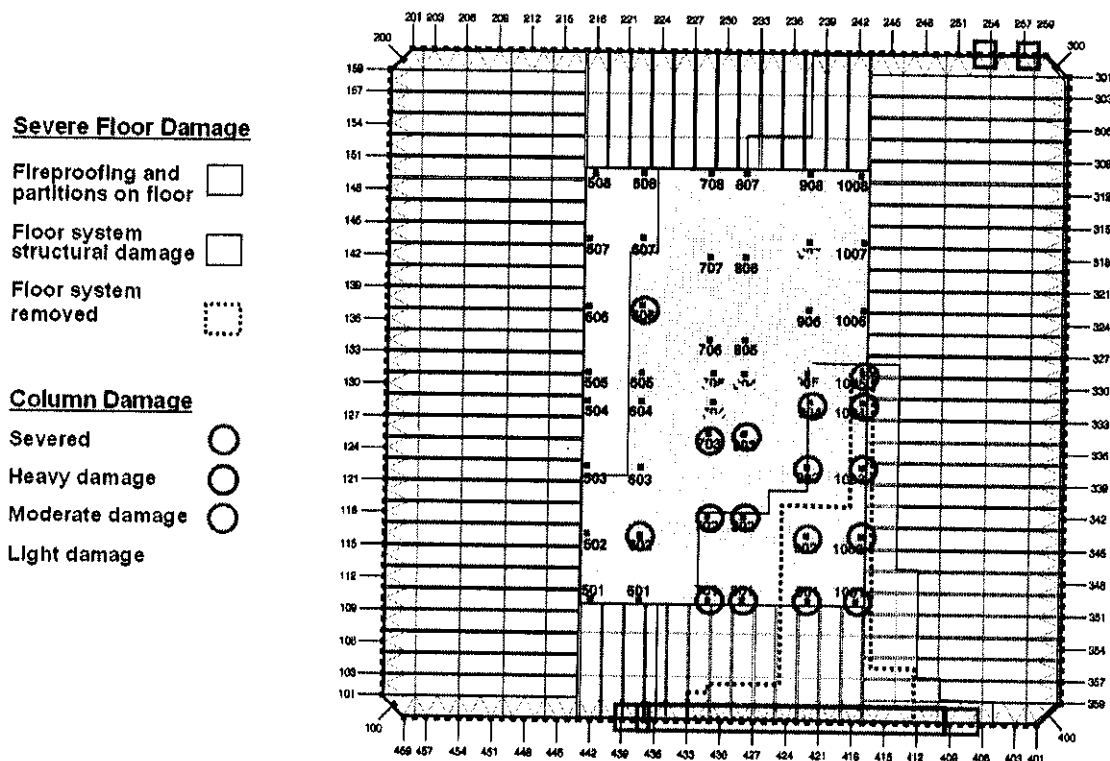
The bulk of the impact damage was confined to six floors. Figure 3–3 shows the combined damage. Floors 77, 84, and 85 were struck only by the outer extent of the wings. Empty of fuel, the light framing

Figure 3-3. Simulation of aircraft impact damage to the 78th through 83rd floors in WTC 2.

The middle of the left wing hit the 78th floor, severing nine perimeter columns and breaking 19 windows on the south face. The SFRM was stripped from the floor trusses over the same width as the building core. The stripping of insulation from the trusses continued inward across the tenant space and about two thirds of the way into the core. There was no direct core column damage from the debris on this floor. However, the southeast corner core column was so damaged on the 80th floor that it broke at its splices on the 77th and 83rd floors.

There was heavier damage to the 79th floor. The left engine and the inboard section of the left wing shattered a 25 ft wide section of the center of the floor slab all the way to the core of the building and severed 15 perimeter columns. Reaching the building core, the debris severed nine columns, heavily damaged another, and abraded the SFRM from the eastern two thirds of the columns and trusses all the way to the north end of the core.

The damage was most severe on the 80th and 81st floors, hit directly by the fuselage. On the lower floor, a chunk of the floor slab was broken, just above the affected piece of the 79th floor. In addition, a 70 ft deep strip along the east side of the core floor was crushed. The north side floor slab sagged along its eastern end. Ten of the perimeter columns severed on the 79th floor were displaced here also. Within the building core, ten columns were severed, including many that were severed on the 79th floor. The SFRM was stripped not only from the eastern two thirds of the core structural elements, nearly to the north wall, but also from most of the trusses on the east tenant space, all the way to the north façade.

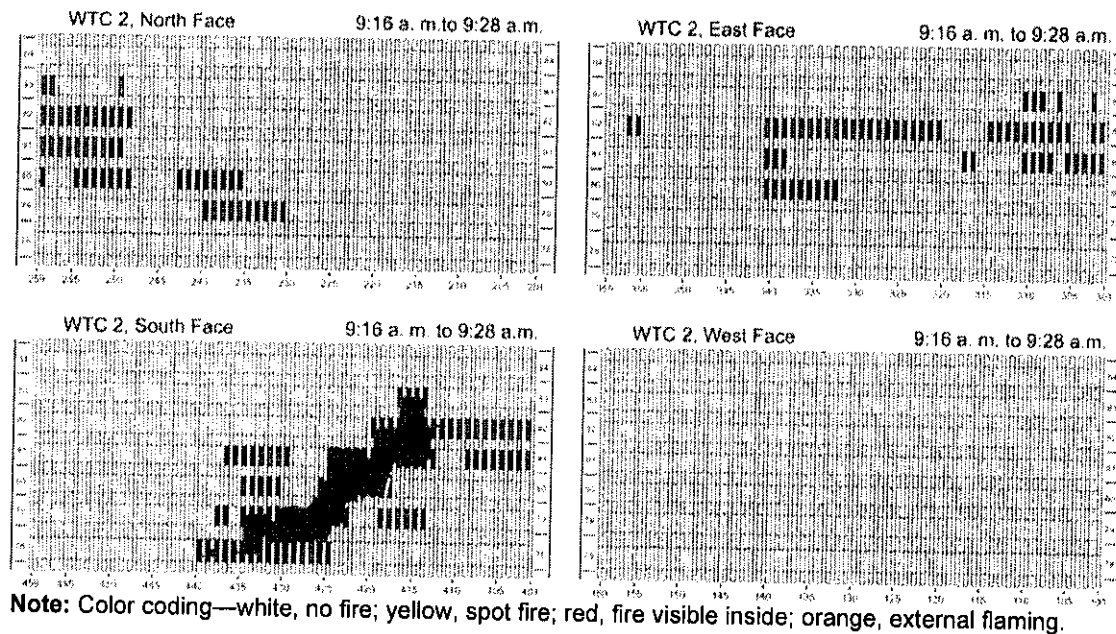
For the next half hour, small fires were burning in and near the aircraft impact cavity on the south side of the building. There were vigorous fires on the east side of the 80th through 83rd floors (Figure 3–4), especially on the northeast end of the 81st and 82nd floors, where the aircraft had bulldozed the office desks and chairs and added its own combustibles. In addition to the ample supply of fuel, these fires had access to plenty of air, as numerous windows on the east face had been blown out by the impact or fireball. They would continue to burn as long as the building stood.

Figure 3–4. Representation of exterior views of the fires on the four faces of WTC 2 at about 9:20 a.m.

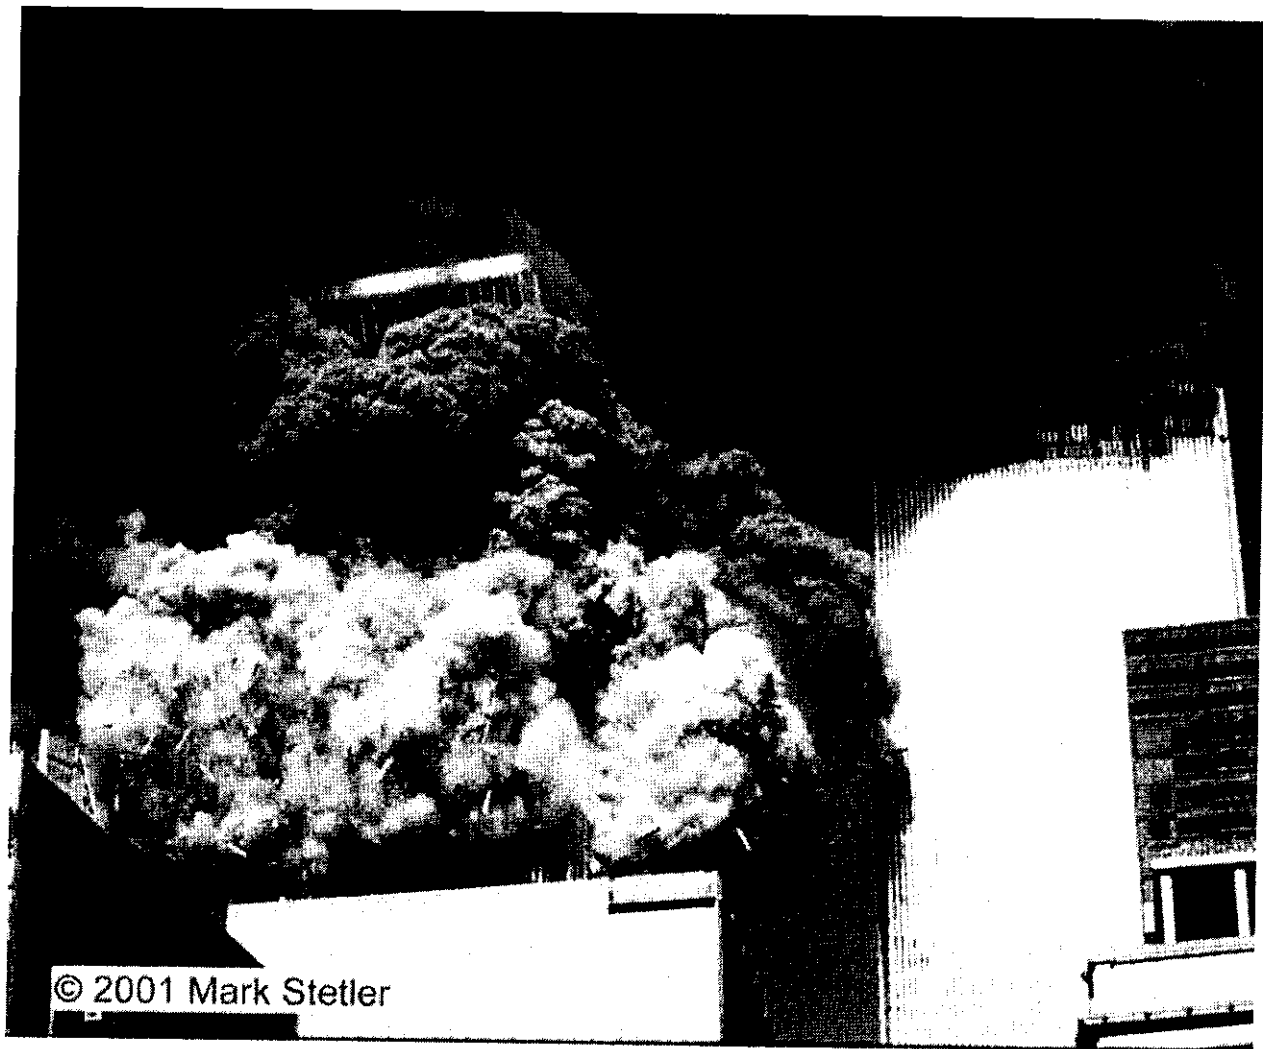
The physical condition of the tower had deteriorated seriously. The inward bowing of columns on the east wall spread along the east face. The east wall lost its ability to support gravity loads, and, consequently, redistributed the loads to the weakened core through the hat truss and to the adjacent north and south walls through the spandrels. But the loads could not be supported by the weakened structure, and the entire section of the building above the impact zone began tilting as a rigid block to the east and south (Figure 3-5). Column failure continued from the east wall around the corners to the north and south faces. The top of the building continued to tilt to the east and south, as, at 9:58:59 a.m., WTC 2 began to collapse.

Figure 3–5. Photograph of WTC 2 tilting to the southeast at the onset of collapse.

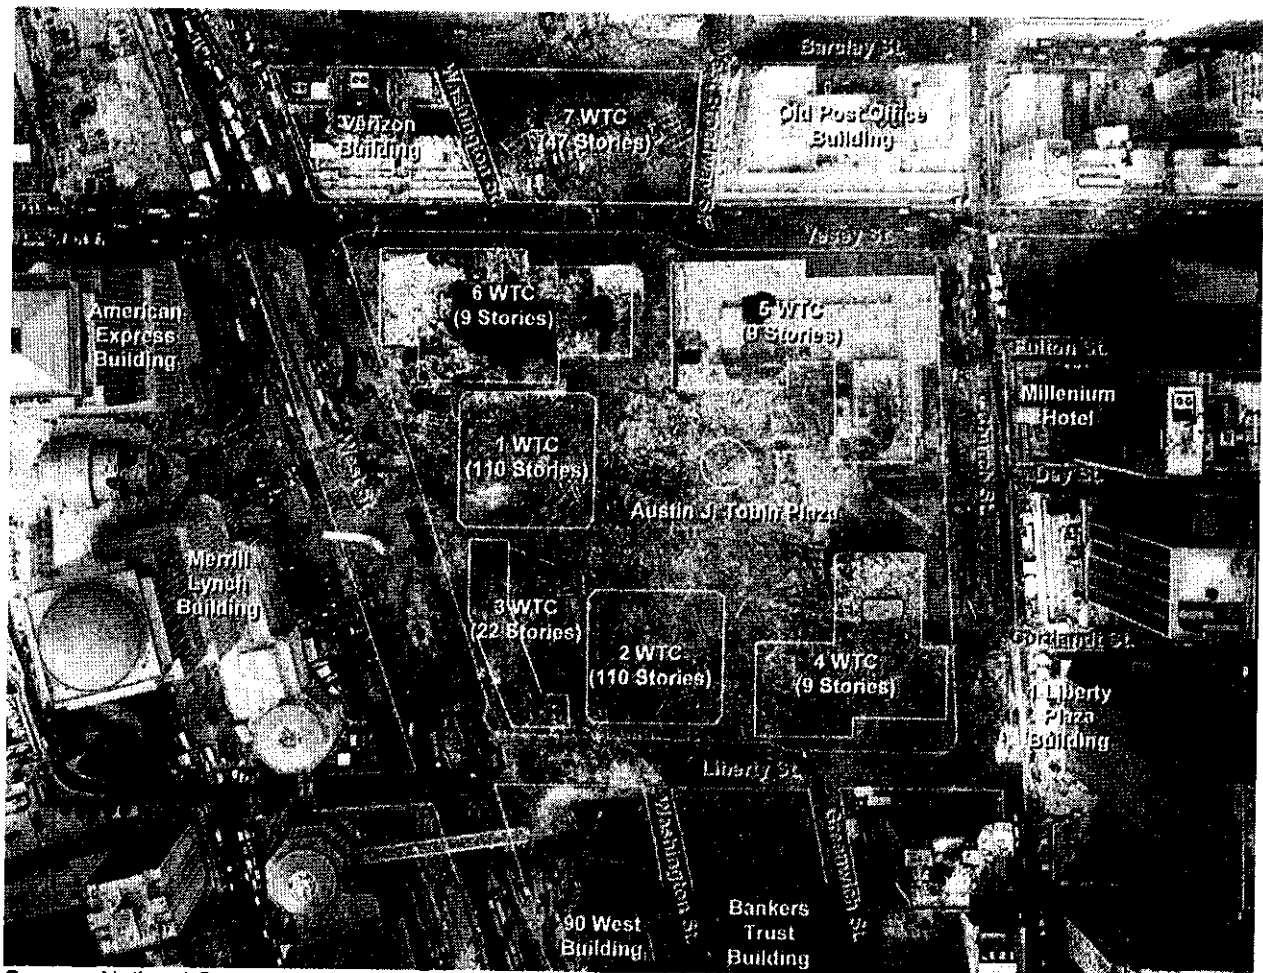
By sunset on September 11, 2001, all seven buildings on the World Trade Center (WTC) site lay in ruins (Figure 4-1). Table 4-1 compiles the likely locations of the decedents.

Figure 4-1. The WTC site on September 17, 2001.
